# NATIONAL TRANSPORTATION SAFETY BOARD

## AIRCRAFT ACCIDENT REPORT

CONTROLLED FLIGHT INTO TERRAIN  
KOREAN AIR FLIGHT 801  
BOEING 747-300, HL7468  
NIMITZ HILL, GUAM  
AUGUST 6, 1997

NTSB/AAR-00/01  
PB00-910401  
Notation 6952B  
Adopted January 13, 2000

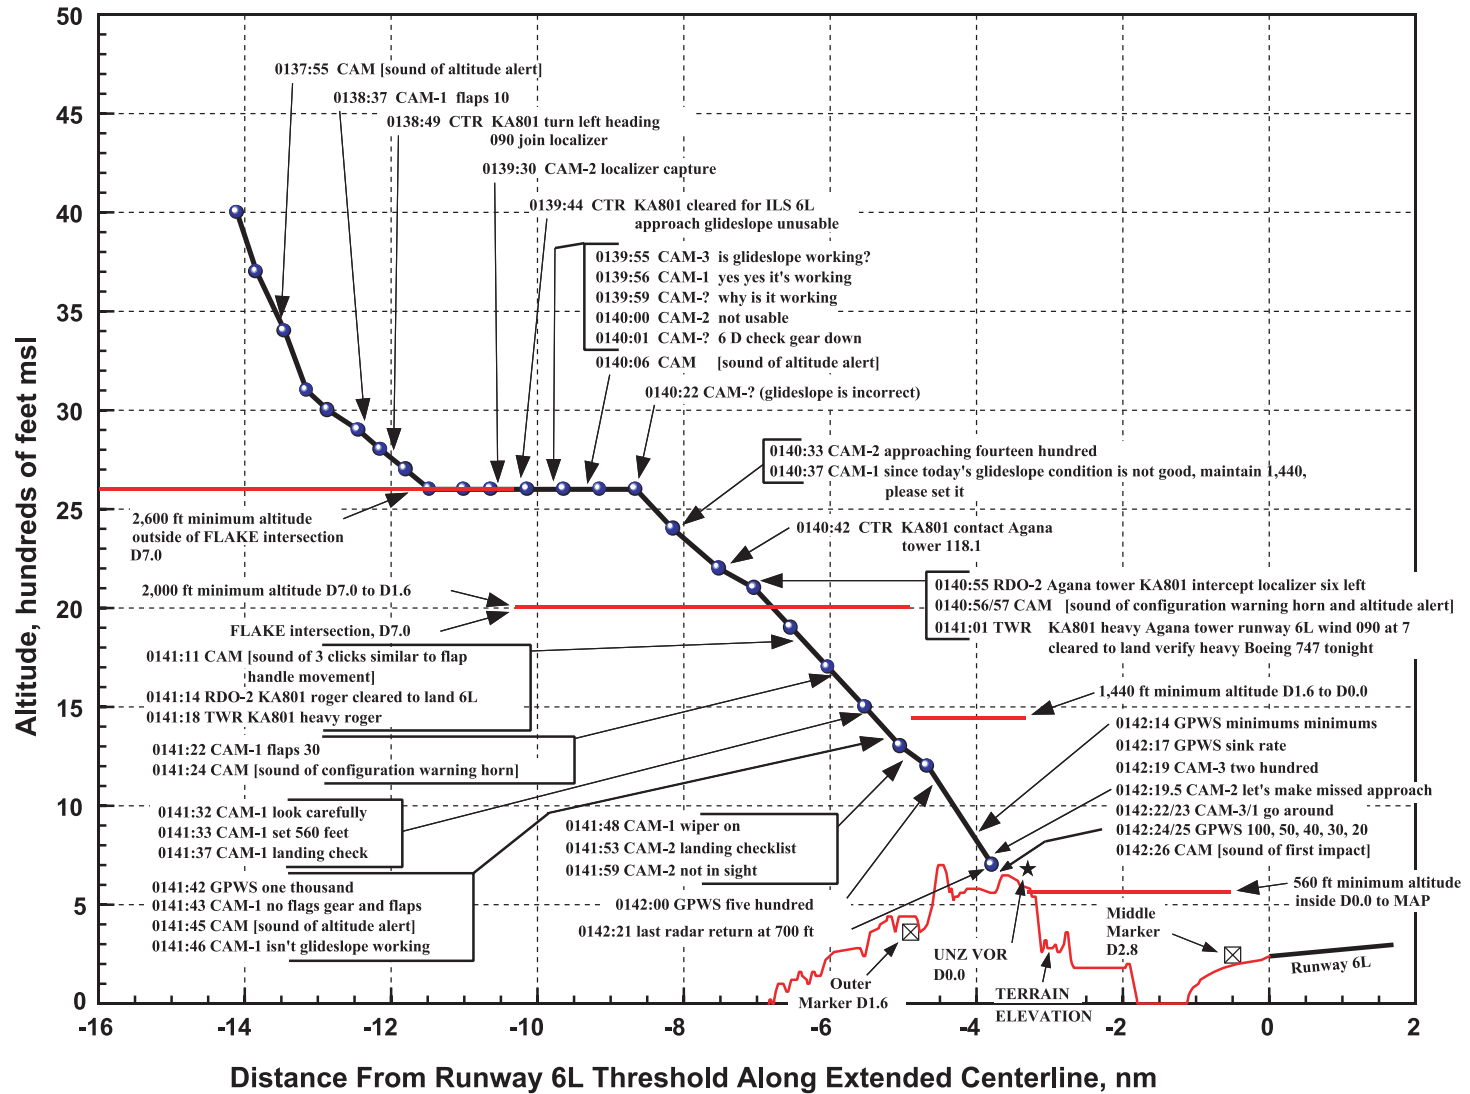
Figure 2. Side view of FAA radar data with selected ATC and CVR communication excerpts.

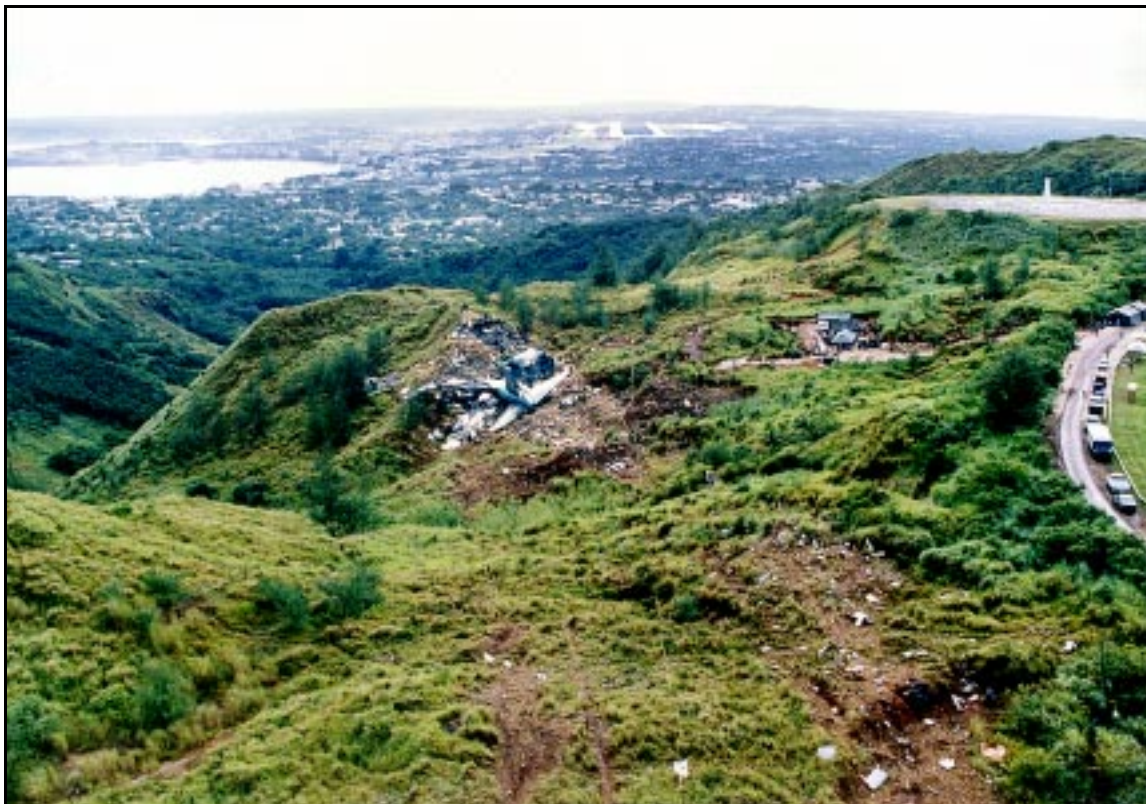
Figures 8a and 8b are photographs of the wreckage from Korean Air flight 801. Figure 8a shows the airplane wreckage in relation to runway 6L, the NIMITZ VOR, and Apra Harbor.<sup>65</sup> Figure 8b provides a closer view of the wreckage and the VOR.

**Figure 8a.** Wreckage from Korean Air flight 801 in relation to Guam International Airport runway 6L (*upper middle*), the NIMITZ VOR (*upper right*), and Apra Harbor (*upper left*).
